Manhole Inspection Summary

Manhole # S65S__006MH

Insp Date: **3/6/08 11:26 AM**

Location Address: **6106 Danville Ave.**

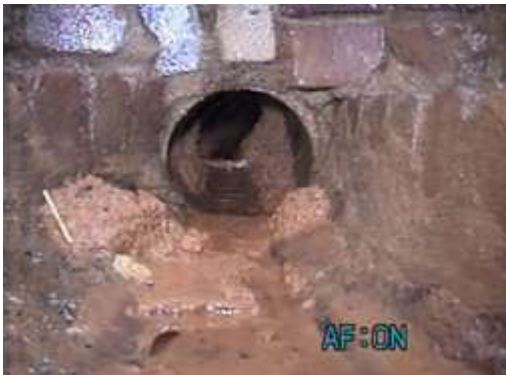
Defect 1

Possible cracked pipe or offset joint.
Review when CCTV is completed.
Incoming 8 O'Clock

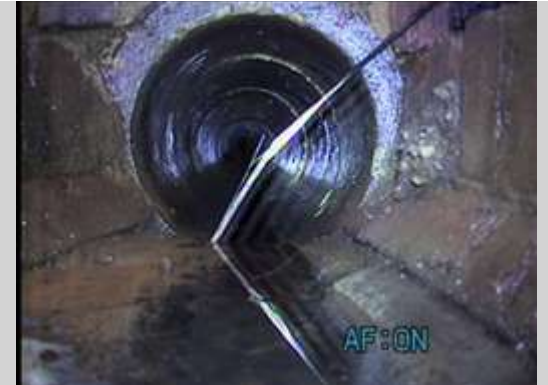
12 O'Clock Outflow

8 in. Circular Gravity Sewer
Pipe Out @ 12 O'Clock

Pipe Height: **8.4** (in.) Rod and Bar (Angled)
Pipe Material: **Clay** ☐ Pipe Lined
Invert Depth: **6.75** (ft.) Flow Characteristics: **Fast**
Deposits: ☒ None ☐ Mud ☐ Sludge ☐ **Debris** ☐ Grease
Silt Depth: (in.) Deposits Extent:
Infiltration: **None** Pipe Seal Cond: **Sound**

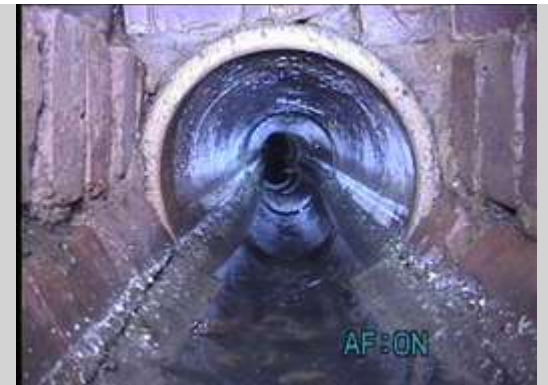
6 O'Clock Inflow

8 in. Circular Gravity Sewer
Pipe In @ 6 O'Clock

Pipe Height: **8.4** (in.) Rod and Bar (Angled)
Pipe Material: **Clay** ☐ Pipe Lined
Invert Depth: **6.71** (ft.) Flow Characteristics: **Slow**
Deposits: ☒ None ☐ Mud ☐ Sludge ☐ **Debris** ☐ Grease
Silt Depth: (in.) Deposits Extent:
Infiltration: **None** Pipe Seal Cond: **Sound**

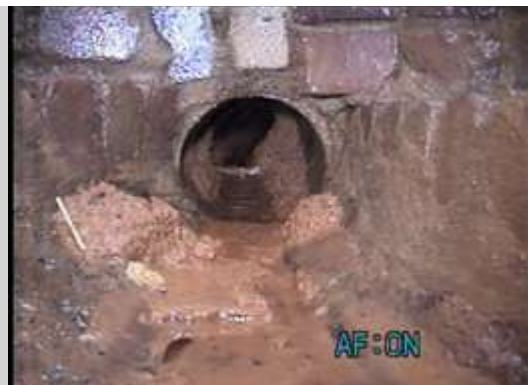
8 O'Clock Inflow

6 in. Circular Gravity Sewer
Pipe In @ 8 O'Clock

Deposits: ☐ None ☐ Mud ☐ Sludge ☒ **Debris** ☐ Grease

Silt Depth: **2** (in.) Deposits Extent: **Heavy**
